Manhole Inspection Summary

Manhole # S33EE_046MH

Insp Date: **2/27/07 11:20 AM**

Location Address: **1010 PARK AVE**

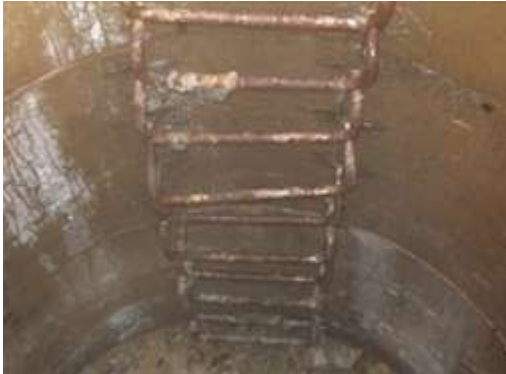
Surcharge ☒ **Evidence Of Surcharge** Depth: **7** (ft.) ☐ Active Surcharge Present

Evidence of surcharge - Bench debris.

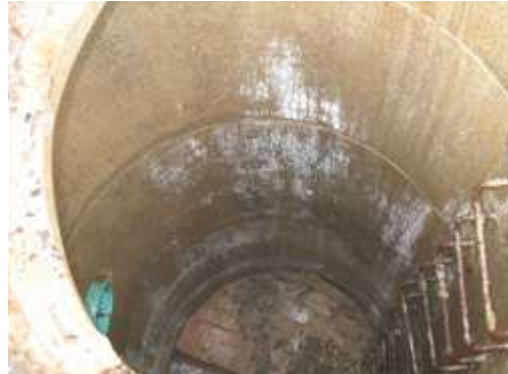
Defect

Chimney / Frame Adjustment ☒ Exists Material: **Brick and Concrete** ☐ Parged Height: **4** (in.)
Condition: ☒ Sound ☐ Cracked ☐ Root Intrusion ☐ Loose Brick ☐ Deteriorated
Infiltration: ☐ None ☒ **Joint** ☐ Cracks ☐ Mortar ☐ Roots ☒ **Wall**

Corbel Material: **Precast Concrete** ☐ Parged Type: **Concentric/Eccentric**
Condition: ☒ Sound ☐ Cracked ☐ Root Intrusion ☐ Loose Brick ☐ Deteriorated
Infiltration: ☐ None ☒ **Joint** ☐ Cracks ☐ Mortar ☐ Roots ☐ Wall

Adjustment and Corbel infiltration.

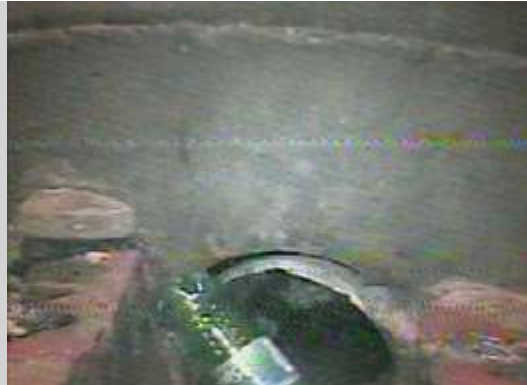
8 in. Circular Gravity Sewer Pipe Out @ 12 O'Clock

Comments **The O12 pipe seal is not flush to the pipe. The I5 pipe in seal is not flush to the pipe.**

Deposits: ☐ None ☐ Mud ☐ Sludge ☒ Debris ☒ Grease

Silt Depth: **0** (in.) Deposits Extent: **Light**
